DISASTER DAMAGE DETECTION AND ITS RECOVERY SUPPORT SYSTEM OF ROAD AND RAILROAD USING SATELLITE IMAGES

KEY WORDS: Damage detection, Emergency transportation route, Decision support, NDVI, SPOT, 2004 Niigata-ken Chuetsu Earthquake

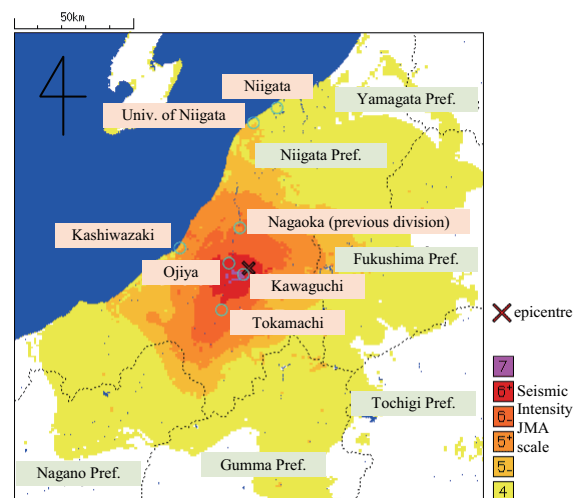
Figure 1. Seismic intensity of JMA scale triggered by 2004 Niigata-ken Chuetsu Earthquake

On October 23, 2004, at 17:56 on JST (18:56 on GMT), a heavy earthquake with a magnitude of 6.8 in JMA (Japan Meteorological Agency) Magnitude occurred in Chuetsu region of Niigata prefecture of Japan. One of the most heavily damaged town was Kawaguchi with an intensity of 7 on the intensity of JMA scale as shown in Figure 1. Not only Kawaguchi town but also Tokamachi, Ojiya city and

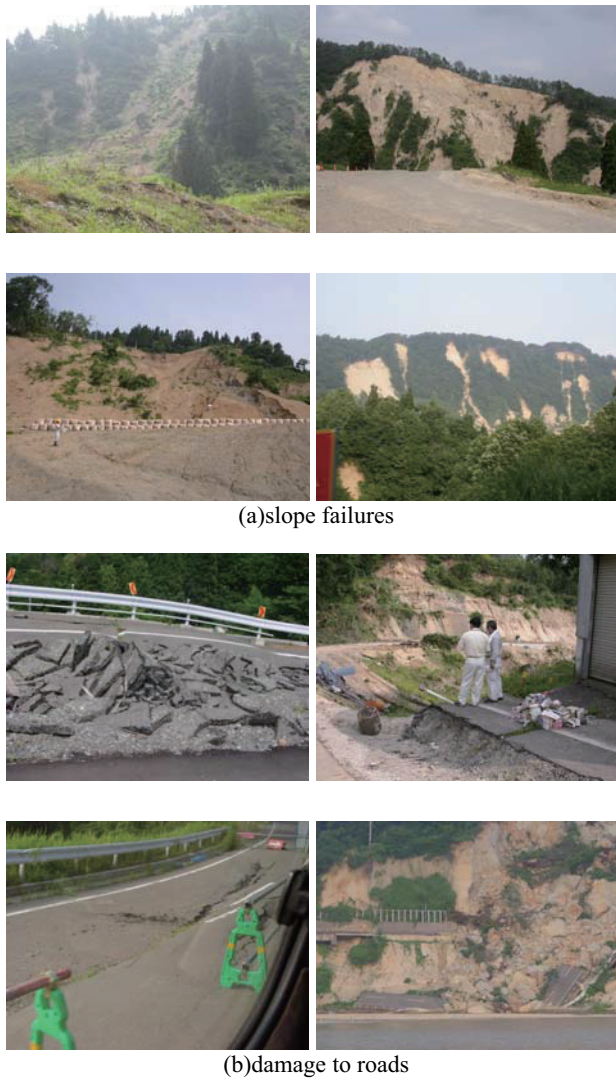
(a)slope failures

(b)damage to roads

Figure 2. Damage triggered by 2004 Niigata-ken Chuetsu Earthquake

The Shinkansen train traveling at a speed of 200km/h was derailed. Many rock and soil slope failures took place, particularly in the mountainous area. These slope failures destroyed roads and railways. The large slope failures were directly associated with structural discontinuities in rock mass such as existing faults, bedding planes, and folds. Figure 2(a) shows the examples of the slope failure.

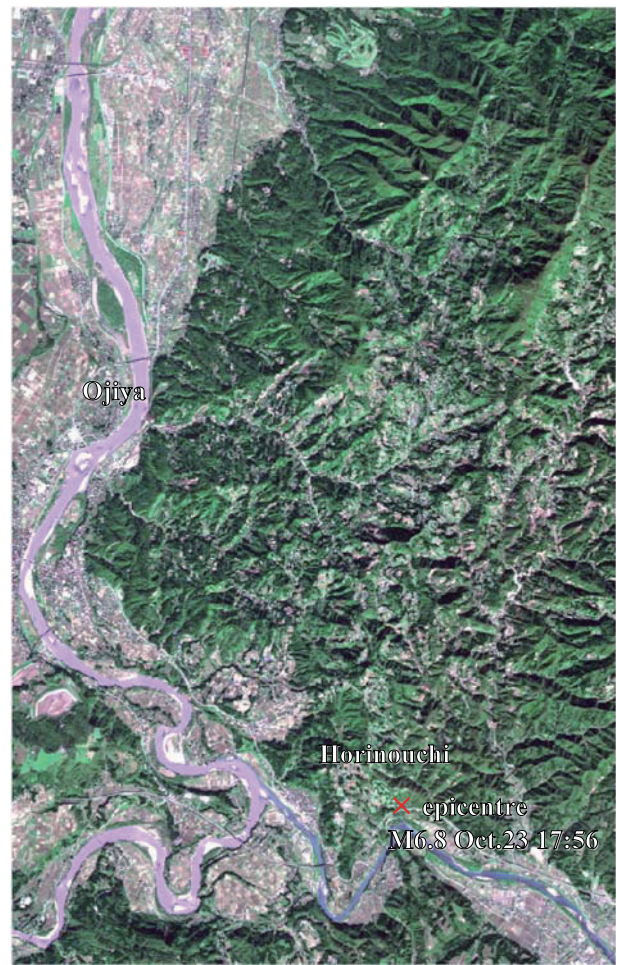
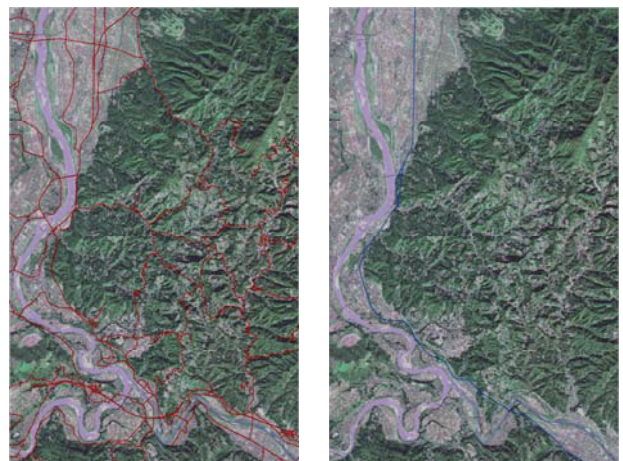
(a)SPOT-5 color composite (R:G:B=band 2:3:1)

(b)road features(red line) (c)railway features(blue line)

Figure 3. Study area

The Great Merger of the Heisei Era has completed in March, 2006. In corresponding to the Merger, several administrative units in Niigata prefecture have changed. This paper, however, uses previous administrative units and names. As shown in Figure 3, the study area of this paper is in and around Ojiya city, Nagaoka city, Kawaguchi town, Horinouchi town and Yamakoshi village which is about 2263 × 3609 pixels (almost 11km × 18km) of SPOT-5 image. The data format is shown in Table 1. The data used in this study has been unified as raster or vector type for convenience of calculation and management.

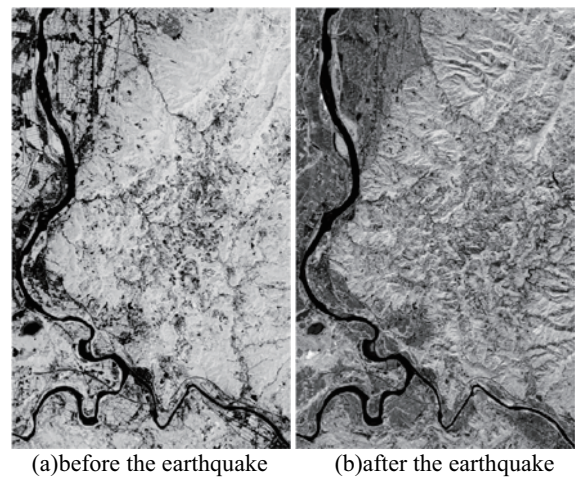
Figure 4. *NDVI* images of the study area

In order to extract earthquake-induced damage to roads due to slope failures, it is effective to see land cover changes, particularly vegetation cover changes, rather than to see the base courses or the subgrades of road directly. Therefore established index *NDVI* shown in eq.(1), well known as an index for vegetation activity, is used in this study. Figure 4 is the *NDVI* image of this study area.

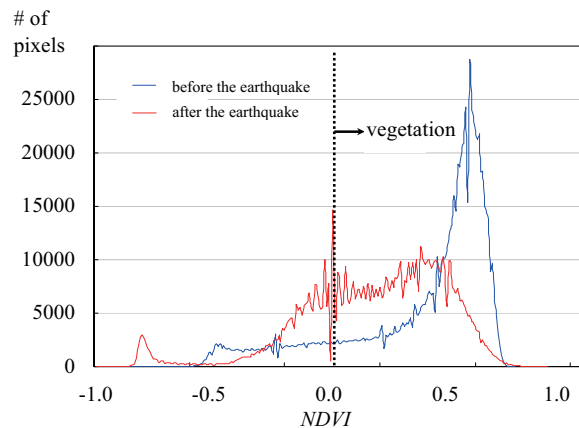
Figure 5. Histogram of *NDVI*

SPOT-5 has 5 bands including a panchromatic band and a SWIR band. The band 2 and 3 images correspond with *Vred* and *NIR* respectively. Figure 5 shows the histogram of *NDVI*s in the study area concerning to before and after the earthquake. By using the histogram of *NDVI*, masked image was calculated where threshold value of *NDVI* is 0. In this study we assumed that vegetation cover has been lost by slope failures after the earthquake and then soil has covered the collapsed area. Based on the assumption, the masked image was merged, and removed agricultural area and flat area (domain of less than 9 degrees of slope). Finally predicted damage polygons were generated as shown in Figure 6.

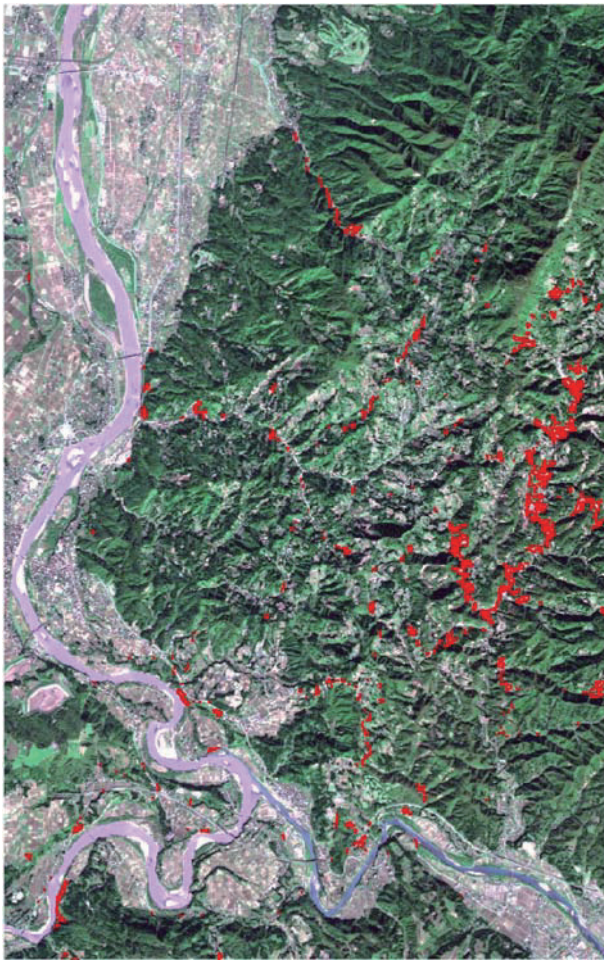
Figure.6 Detected damage area by *NDVI* analysis
Red polygon : detected damage polygons
(background image : SPOT-5)

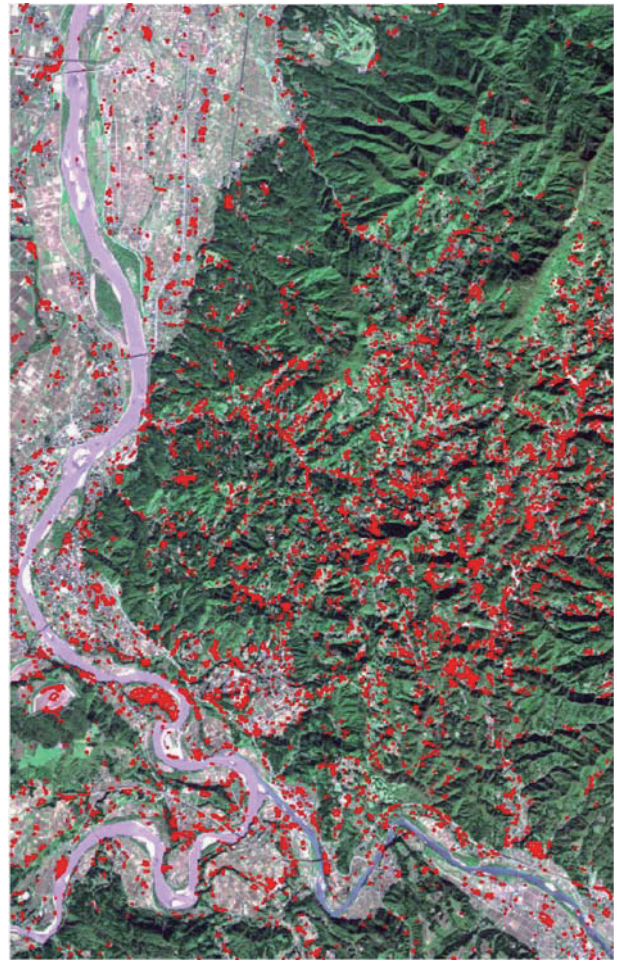
Figure 8. Detected damage area by texture analysis
Red polygon : detected damage polygons
(background image : SPOT-5)

Two damage detection parameters were applied to whole image of the study area. Similar to the *NDVI* analysis, the domain of less than 9 degrees of slope has been deleted. Then damaged area by the texture analysis is detected. Figure 8 shows the result image of texture analysis. The number of detected polygons by texture analysis was 5 times of *NDVI* analysis.

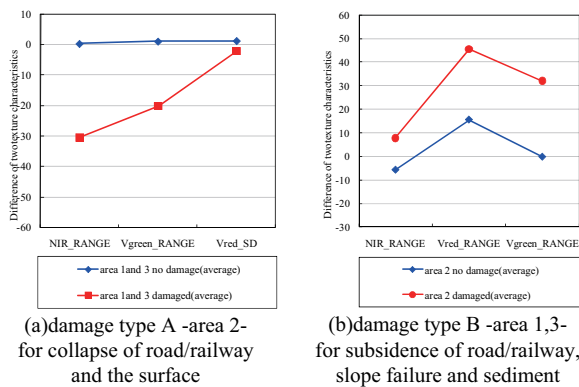
Figure 7. Change in characteristics of texture(difference of texture) between damaged area and no damage area

At the phase of training, three test case areas were prepared. Initially texture characteristics (e.g. the range, the standard deviation) for three bands were calculated using the segment polygon derived by a segmentation analysis. Based on damage characteristics as shown in Figure 7, two damage detection parameters which depend on damage type were decided as follows;

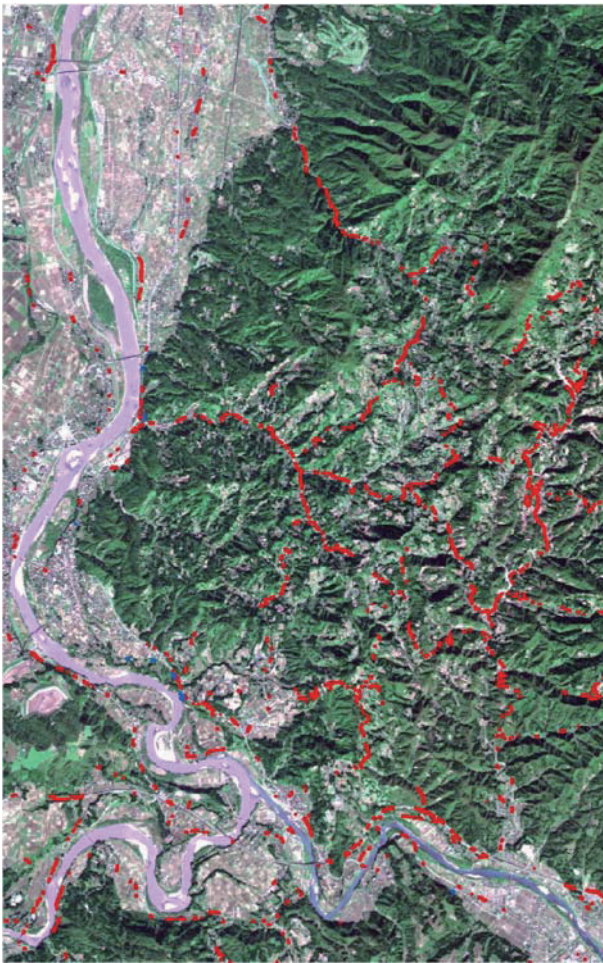
Figure 9. Post processed (merged) damage area
 Red polygon : damage of road
 Blue polygon : damage of railway

Two detected images were merged (Figure 9) and the damage area affecting to 45 routes or Joetsu local line were extracted by comparing road/railway polylines. Accuracy assessment of this merged image has been done with two indices as follows;

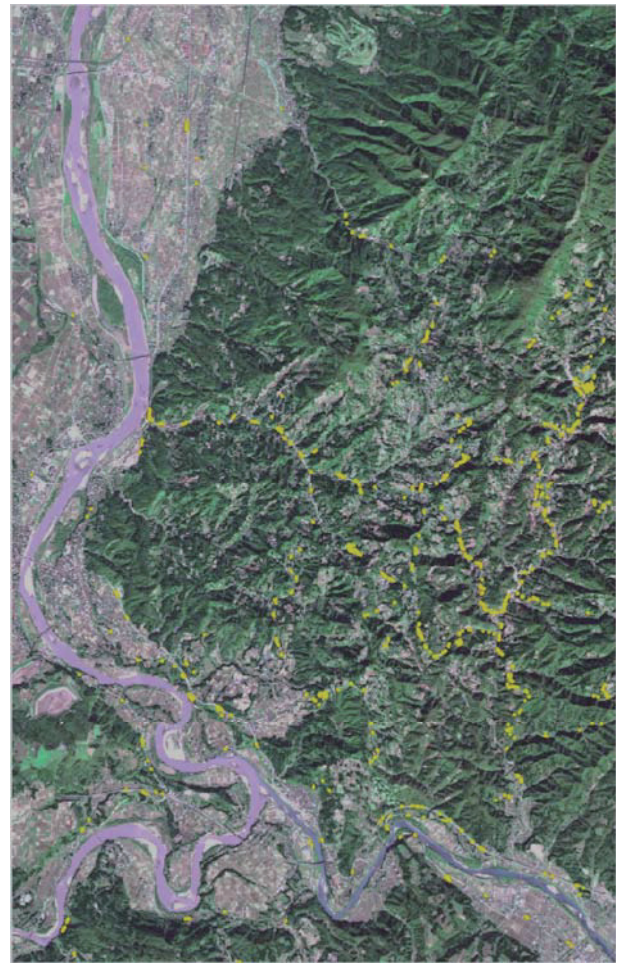
Figure 10. Verification polygons (yellow polygon)

Figure 10 shows the verification data for accuracy assessment. The accuracy assessment result is shown in Table 2. The percentage of detection accuracy was about 66-68%. The total accuracy that means a reliability of the analysis was almost 26%. It is a reason that this had little number of the verification polygons. The road damage extraction results for Yamakoshi village located in the mountainous area had a better accuracy. Nevertheless, road damage extraction results for flat and hilly

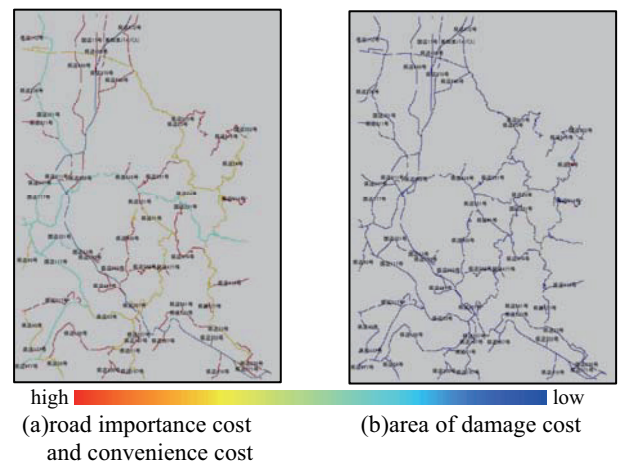
Figure 11. Examples of cost-raster (cost grid)

A GIS using detected road/railway damage data was developed. To support the emergency transportation route decision, a case study of the GIS has carried out. In the case study, the route was calculated by using weighted-cost distance, here the influence of cost-raster (cost-grid) data was as a parameter of the analysis. The aim of this case study is to decide the most suitable emergency transportation route. Figure 12 and 13 show the results. The results show that combination of influence rate controls the transportation route. In general when we transport supplies (reliefs), cost-raster is used and when we secure

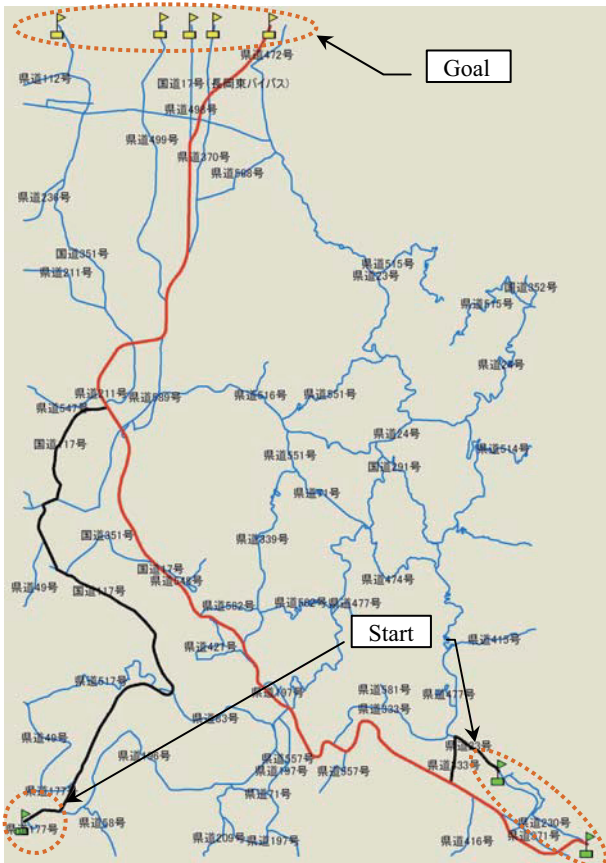
国道 : National highway
 県道 : Prefectural road
 — : minimum distance route
 — : minimum distance route from each node

Figure 12. Expected minimum distance route for transporting supplies to damaged area
 function: (road importance cost) × 0.4 + (area of damage cost) × 0.4 + (damage type cost) × 0.4

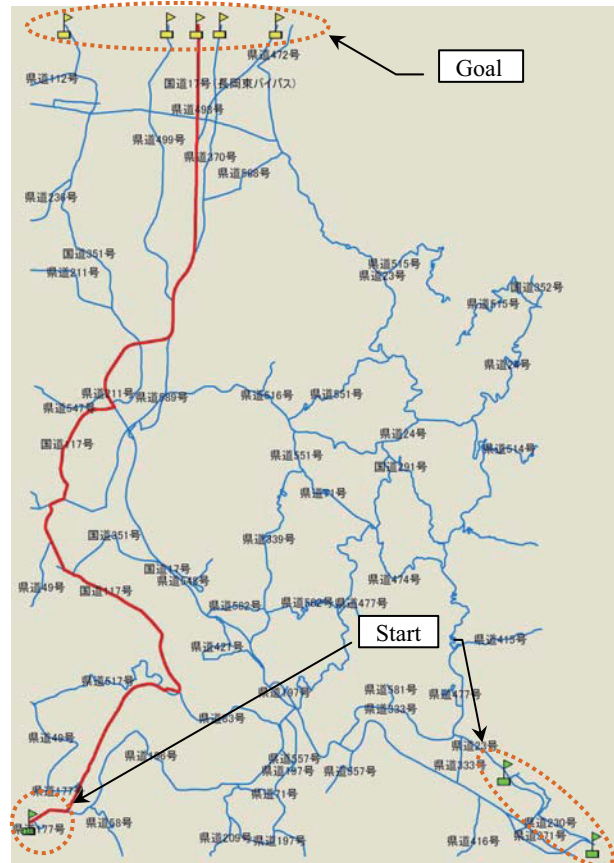
国道 : National highway
 県道 : Prefectural road
 — : minimum distance route

Figure 13. Expected minimum distance route for transporting supplies to damaged area
 function: (area of damage cost) × 0.5 + (damage type cost) × 0.5

transportation route for residents in isolated district, cost factors both area of damage and cost of damage type are used. The result of this case study includes several problems to the actual use. In fact much amount of data can't be prepared like this case study. Therefore a GIS using this kind of weighted-cost distance function is useful in obtaining broad overview for understanding the damage and emergency route situation. But, other kind of cost-grid database or detailed cost evaluation method has to be investigated in future. And also wide area analysis is required for emergency route decision.
